6 DAMAGE TO AIRCRAFT BY BLAST.

NPG REPORT NO. 1058

U. S. NAVAL PROVING GROUND
DAHLGREN, VIRGINIA

First Partial Report
on
Damage to Aircraft by Blast

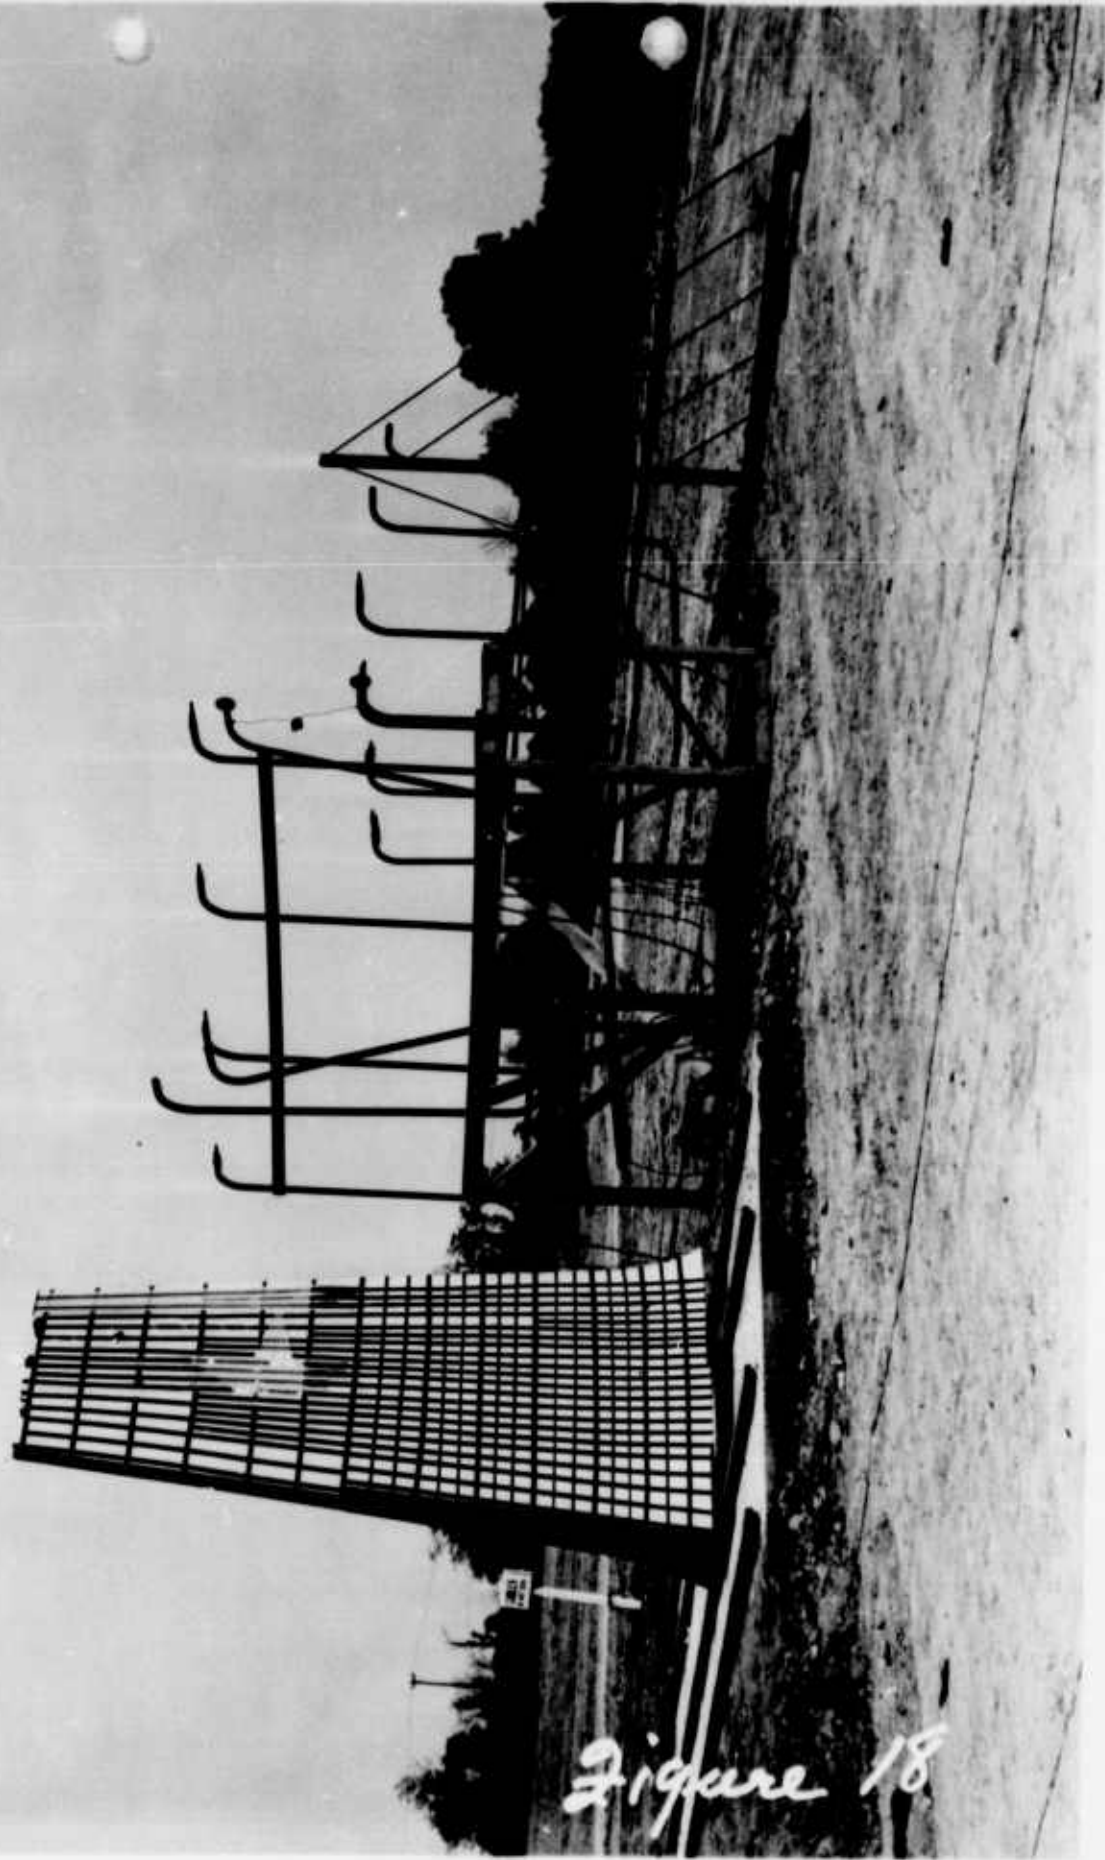
NP9 49328
MIT Blast Program - P9F right hand outer wing panel mounted on rails imbedded in a concrete slab. The wing attachment fittings are held to the 1" armor plate by steel pins.

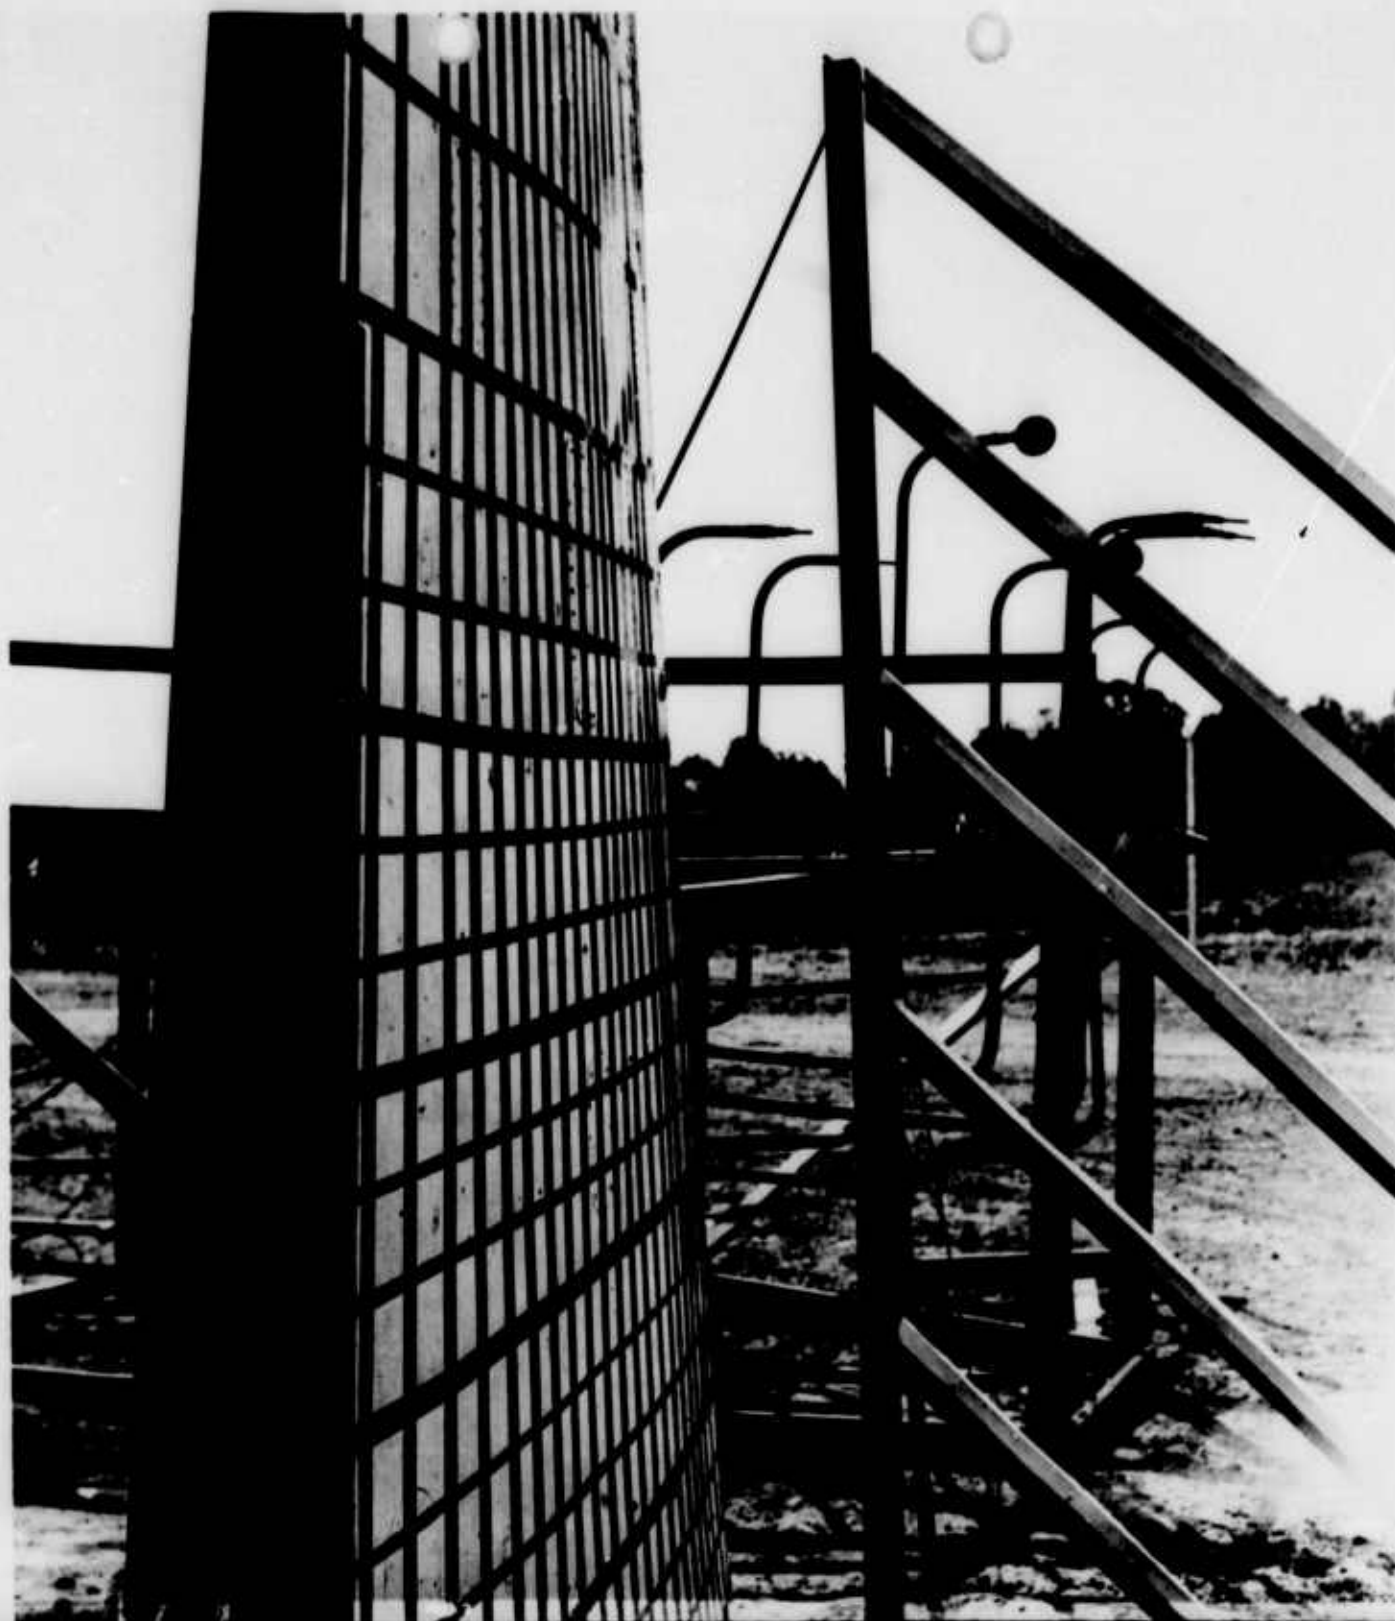
Figure 37

Damage to Aircraft by Blast - A rear view of the under surface of model F9F-4, RH-Outer wing panel showing dishing-in of movable leading edge resulting from detonation #24.

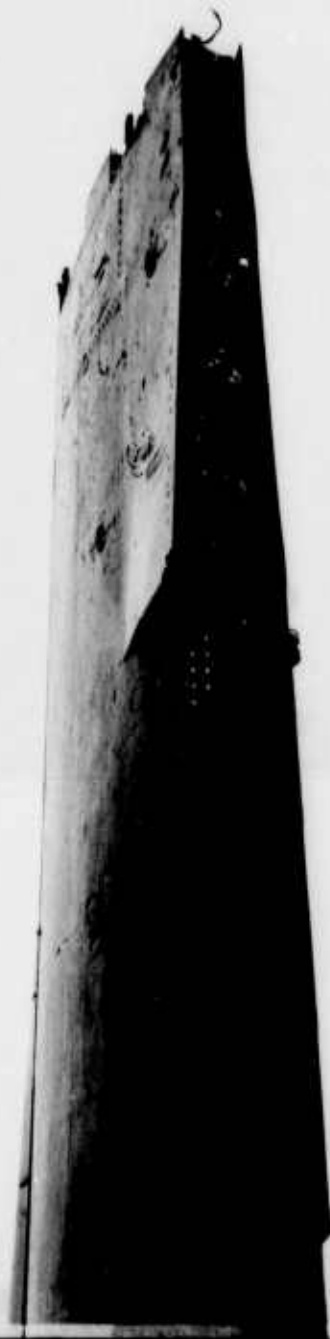
Figure 42

Damage to Aircraft by Blast - A rear view of the upper surface of model F9F-4, RH-Outer wing panel showing damage to trailing edge and skin resulting from detonation #27. Note protruding movable leading edge.

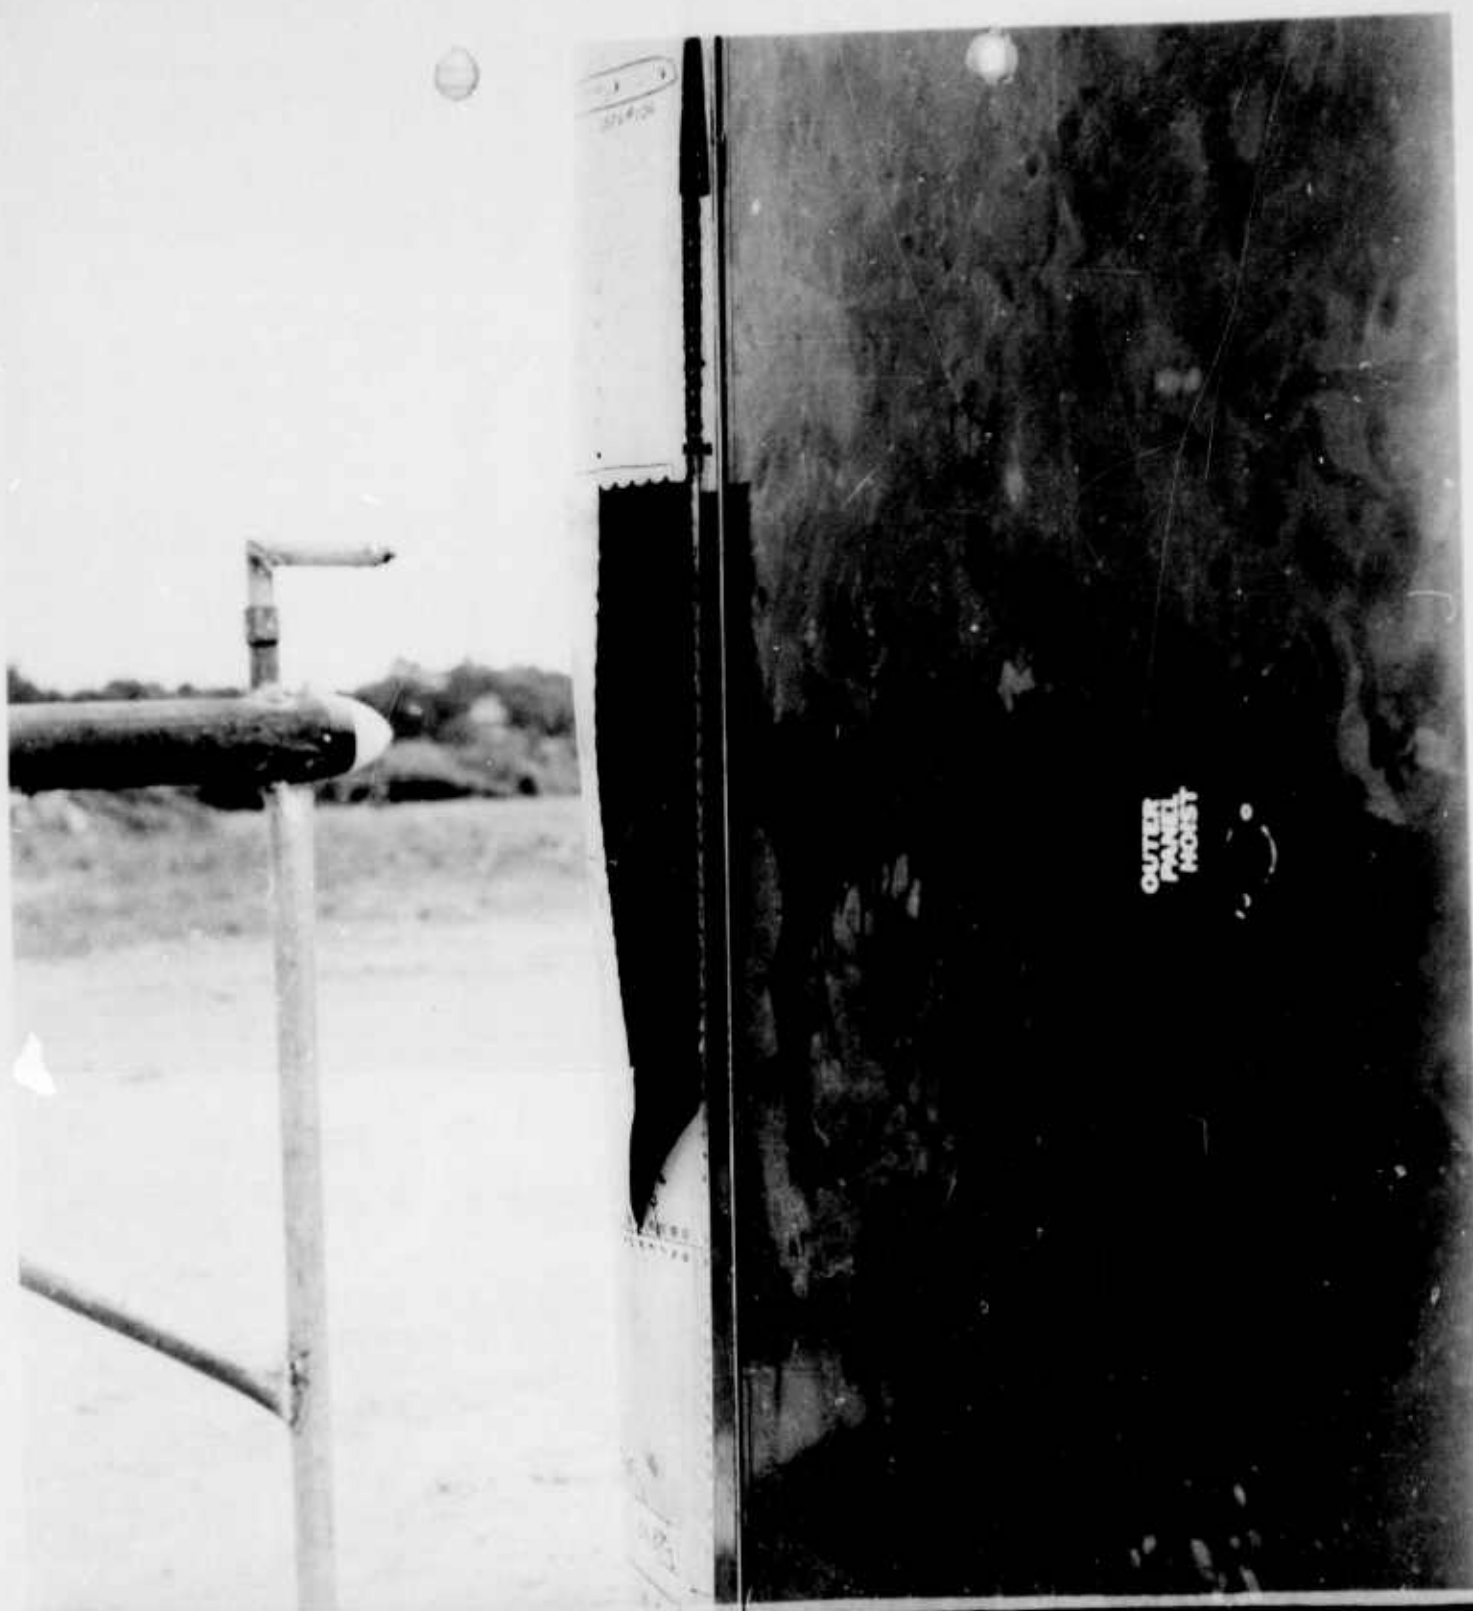
Figure 43

Damage to Aircraft by Blast - A rear view of upper surface of model F9F-4, mid-outer wing panel, showing ruptured chordwise ribs at stations #98, #110, and #122, and skin, resulting from detonations #22 (began to crack) thru #27.

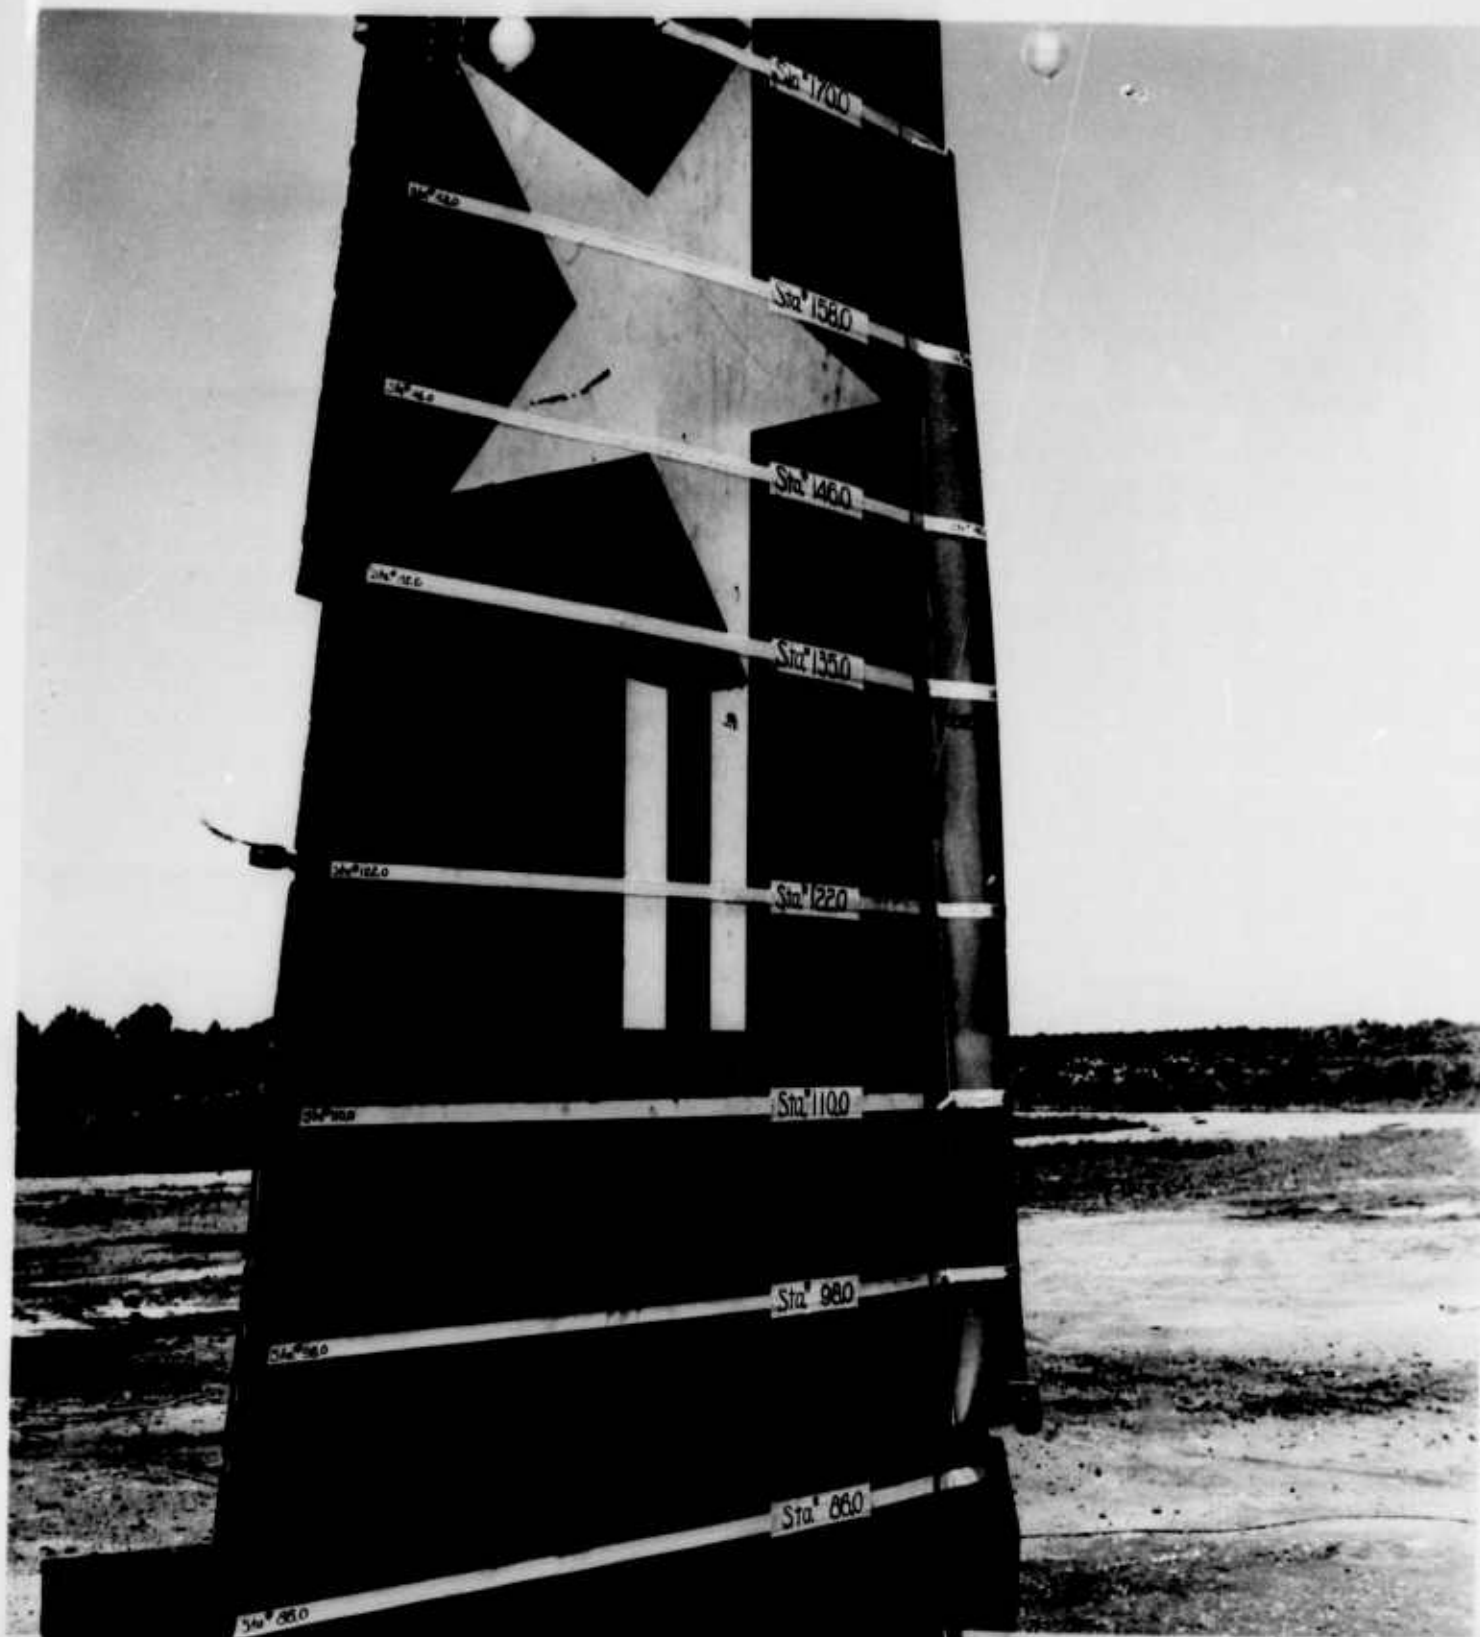
NP9-50783 1 July 1952
 Damage to Aircraft by Blast - A rear view of upper surface of model
 F9F-4, LH-Outer wing panel showing damaged movable leading edge
 resulting from detonations #30 and #31.
 Figure 46
